# **Taylor Run: A Stream Worth Protecting and Preserving**

**Why Nutrient Reduction Estimates for Some “Stream Restoration”  
Projects May Be Greatly Overstated**

**Final Report of the Taylor Run Monitoring Project, Contract 17052  
March 31, 2022**

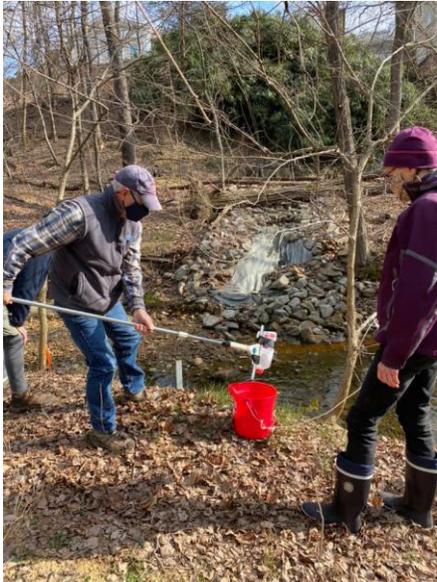
Chuck Kent and Rita drawing sample at TayRun 1.5 (Downstream)

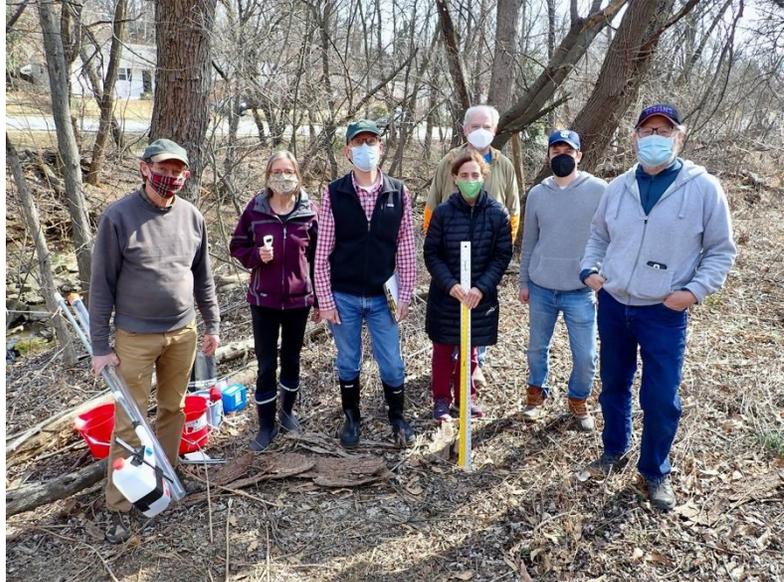
Russ Bailey, Rita Leffers, Bill Gillespie, Trisha Gruesen, John Fehrenbach, John Winstead and Don Bobby sampling at TayRun 1.8 (Upstream)

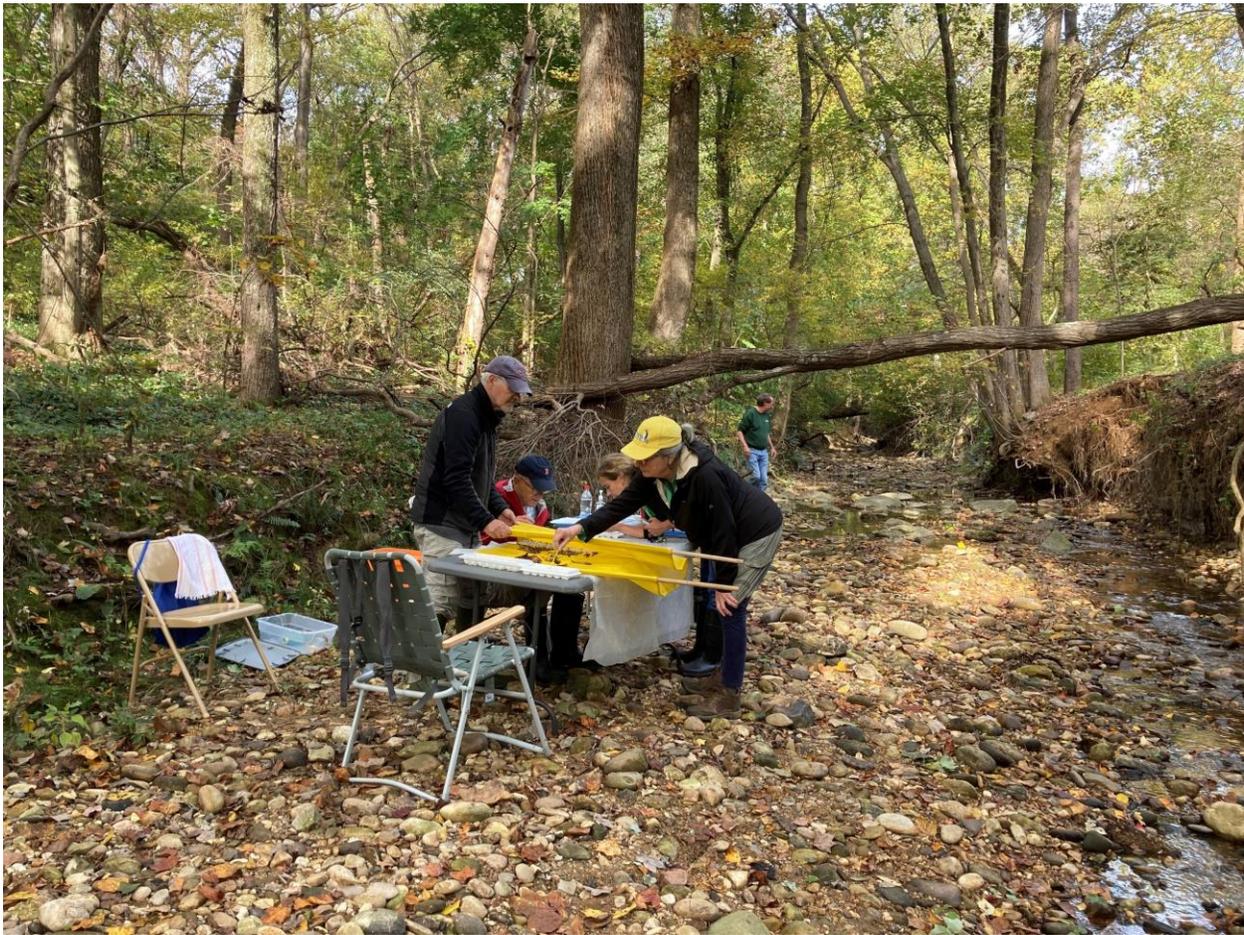
Chuck Kent, Bill Gillespie, Trisha Gruesen, Amy Krafft and Russ Bailey sampling for macro-invertebrates October 28, 2021

The volunteer group performed three macroinvertebrate surveys or "pulls" to evaluate the presence of life in the stream; these took place on May 7, August 8, and October 28, 2021. The surveys were conducted at stream riffles near the NRCA downstream sampling site.

The May 7 pull was led by Emily Bialowas of The Izaak Walton League, a certified stream monitor. The August 8 and October 28 pulls were led by Trisha Gruesen, one of the volunteer water quality monitors, who took the Izaak Walton training in macroinvertebrate identification and monitoring protocols and was certified by the League to be a water monitoring leader.

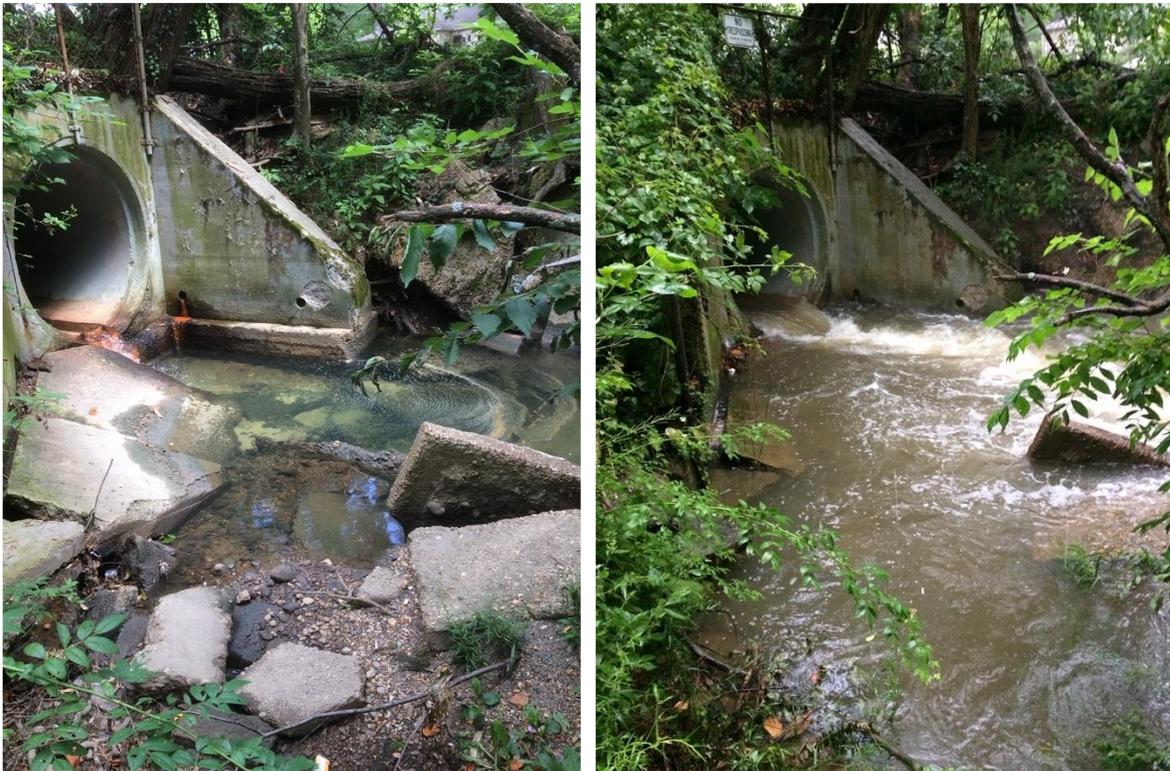
Stream flow on Taylor Run is low most of the year. Occasionally, during rain events, the stream flow increases dramatically. The picture on the left below shows typical low flow conditions. The picture was taken June 27, 2021, at 11:30 a.m. The picture on the right was taken on June 10, 2021, at 5:56 p.m. during a heavy rain event.

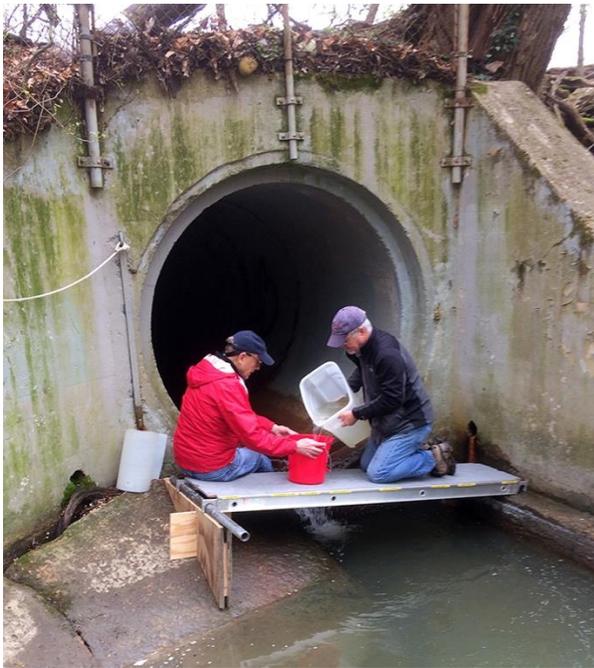
Bill and Chuck measuring flow at TayRun 1.8

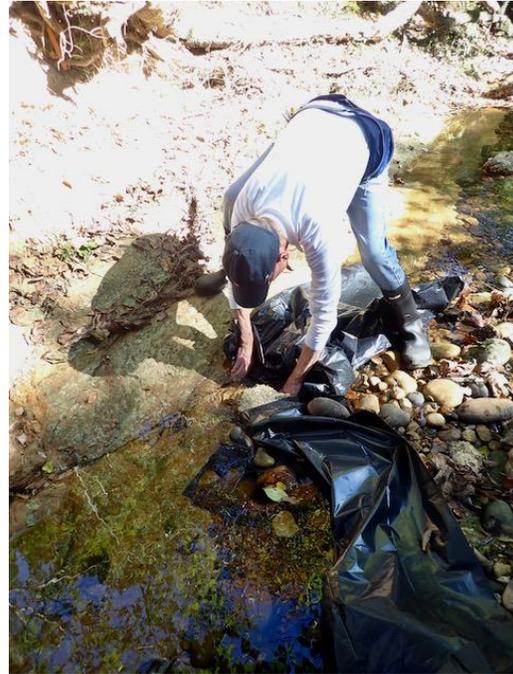
Bill capturing flow at TayRun 1.7

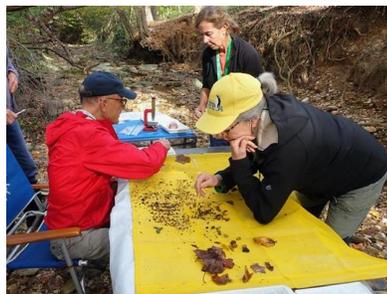
Bill, Trisha and Amy Krafft sorting macro-invertebrates

The first survey, performed on the morning of May 7, 2021 found 145 midges, 68 mayflies, 41 worms, 3 true flies and 2 lunged snails. The Save Our Streams (SOS) Multimetric Index Score was 5. A score of 5 indicates an unacceptable ecological condition. The SOS ecological ranking systems is summarized below.

The second survey was performed on the morning of August 5, 2021. The survey found 64 worms, 26 midges, 13 mayflies, 11 common net-spinning caddisflies, 7 caddisflies, 5 black flies, 4 crane flies and 2 lunged snails. The SOS score was 3 indicating an even poorer ecological condition than the first survey.

The third survey, conducted on the morning of October 28, 2021, yielded 92 caddisflies, 40 worms, 24 common net-spinning caddisflies, 16 midges, 8 mayflies, 4 black flies, 4 scuds, 2 true flies and 2 lunged snails. The SOS score was 7, an improvement over the two previous surveys but still a score of unacceptable ecological condition.

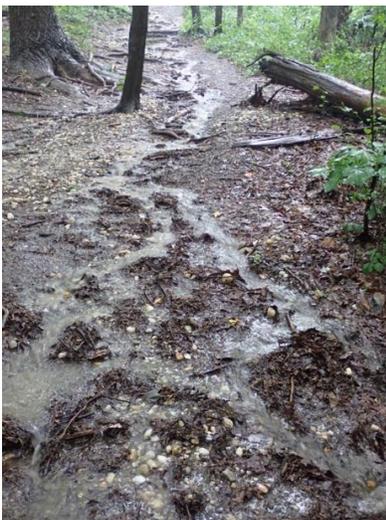
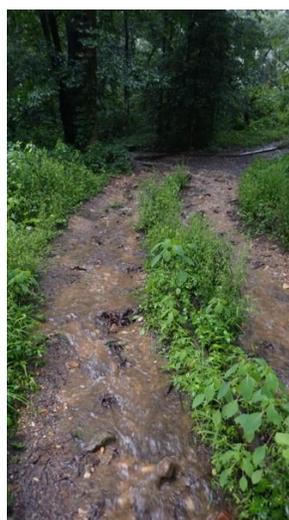
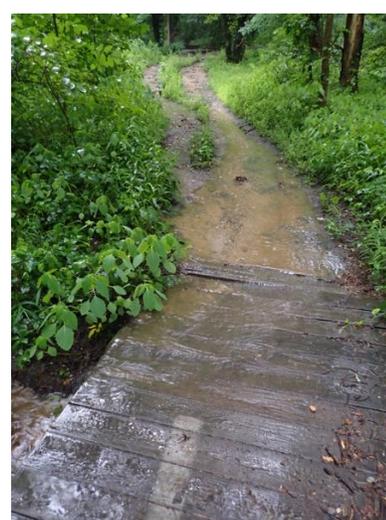
The best thing that can happen to an abused urban stream is to put Best Management Practices (BMPs) in place upstream. These BMPs can slow down, filter and capture stormwater flows. At Taylor Run, there is physical space on public land for BMPs including stormwater retention ponds, bioswales, raingardens, and smaller measures. Implementing erosion control measures within the park along park trails, along the stream banks, and in Chinquapin Park above Taylor Run would slow down and reduce nutrient pollution that finds its way into Taylor Run.
